# **Heritage Impact Assessment of the Nessie Knight Hospital near Qumbu, and the Mjanana District Hospital near Encobo, both Eastern Cape**

# Heritage Impact Assessment of the Nessie Knight Hospital near Qumbu, and the Mjanana District Hospital near Encobo, both Eastern Cape

## Contents of Report:

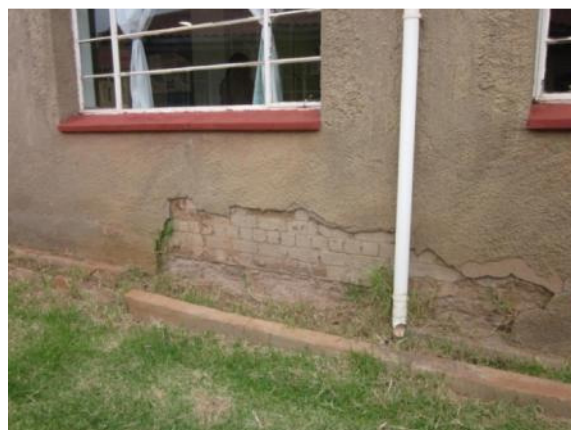
The buildings on the site are ill-maintained. This has resulted in much damage at foundation level, particularly regarding leaking septic tanks and French drains. This issue has to be tackled in tandem with the construction of the new extensions to the hospital.

**Fig 10: Plaster spalling – damp and lack of maintenance**

**Demolition is not an option at this point. The building is solid and well built, but at the same time needs urgent and well supervised maintenance. The services of an appropriate heritage architect should be engaged in informing the links between the old building and the proposed new extension in line with prevailing conservation charters. A defined but negative junction must separate the two buildings, and it is recommended that the new building take some clues such as massing and proportion of fenestration, openings and structure from its existing precedent.**

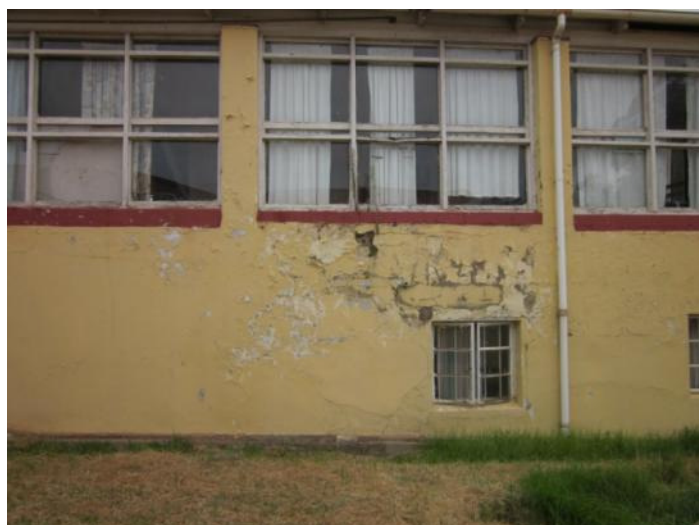
The rear of the building consists of a massive glazed veranda with timber framed window enclosures. Low level steel framed casement windows allow light into basement rooms. Given the lack of maintenance to these timber frames, many are rotting and need repair. However, it appears that this part of the building will be sutured onto the new extension. As noted earlier in this report, water damage at foundation level is severely affecting elements of this elevation.

**Fig 9: Enclosed veranda on rear elevation of main building**

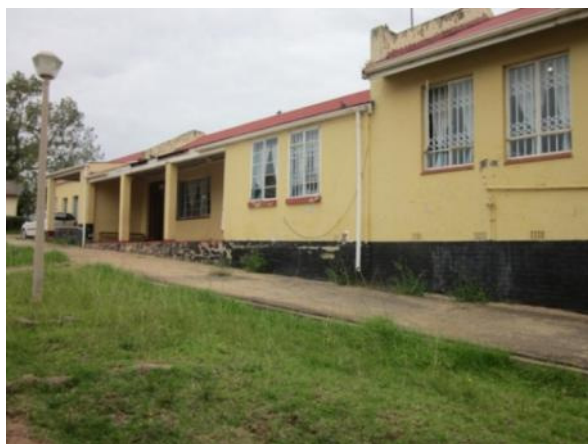
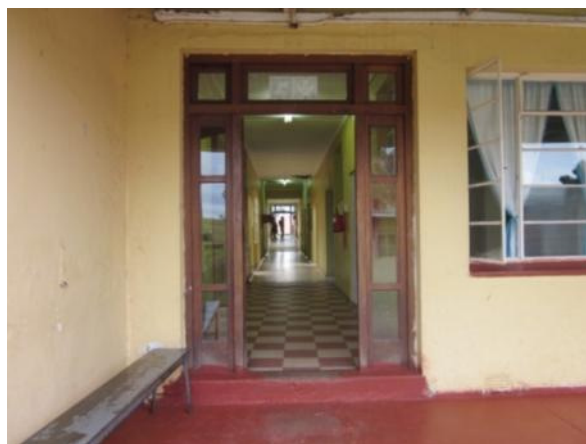
**Fig 15 & 16: rear elevation – note roof heights and mahogany doors**

A redeeming feature of this building is the set of mahogany doors which are located on the veranda on the long north eastern elevation. It is recommended that these doors can be redeployed, perhaps at the junction of the old building and the proposed new extension to the rear.

**Demolition is an option and it is recommended that the entrance doors on the north eastern elevation be reused in the design of the proposed extension to the main wards.**

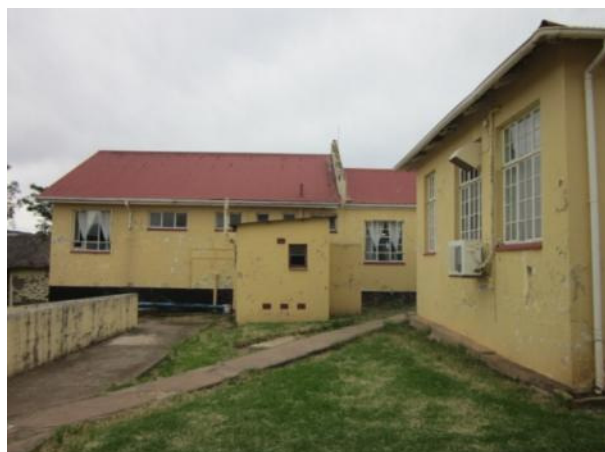
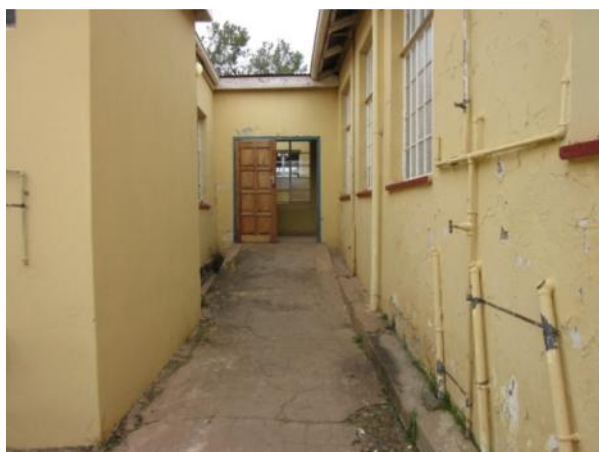
The buildings are all of painted locally made bricks with corrugated-iron. Variant standard steel windows are used, and the lack of cohesion of such elements leads to its discord.

**Figs 17 & 18: Showing random planning and the resultant inefficient and useless spaces.**

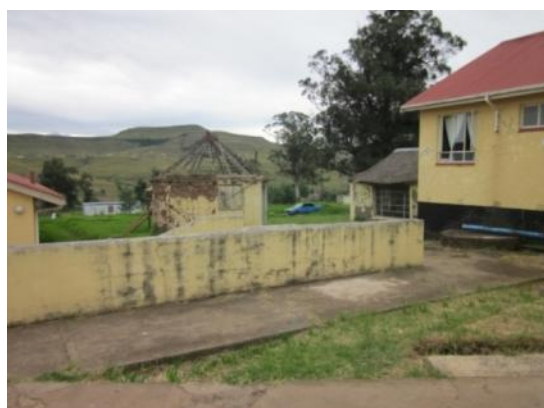
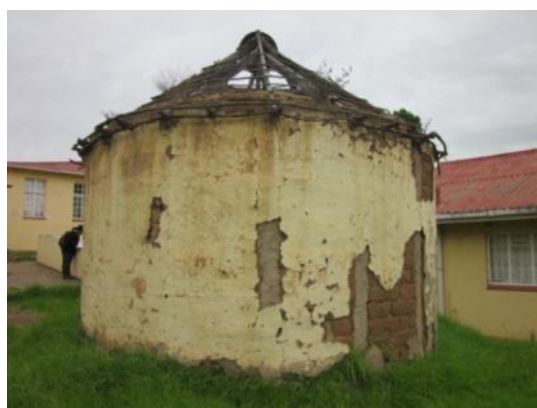
Given diagnostic features, this rondawel of mud brick and gumpoles is very likely to be over the age of 60 years and thus subject to protection in terms of the South African National Heritage Act. It has been plastered in the past, most of which is spalling, and its thatch roof is long gone. A steel window has been added to the south. The practicality of its repair and reuse is limited, and it is felt that it is important to concentrate the repair and reuse of such buildings to other parts of this site.

**Figs 19&20: Old mud brick rondawel**

**Due to its condition and location within the extended development, demolition is an option**

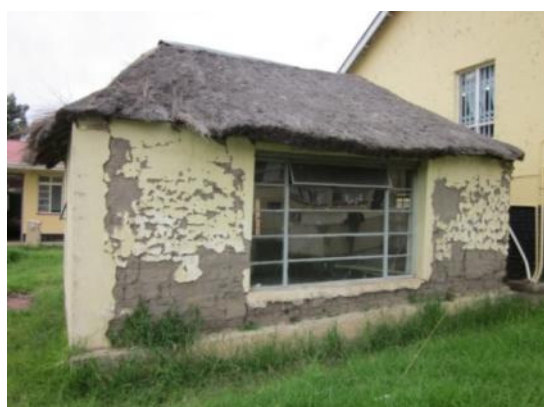
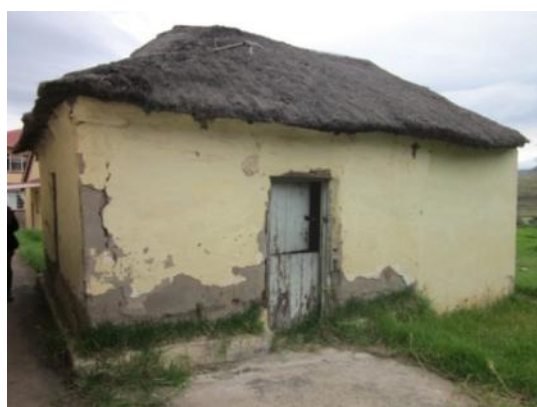
**Figs 21&22: Mud brick building showing steel windows and wooden stable door**

This example is located distant from the other examples, and is different as it has a steel window inserted on the south western façade. The south eastern façade has a small 6/6 sliding sash window, and the north-eastern façade a wooden stable door. The north-western façade has had top-hung steel section windows inserted. The roof is still thatched, and the walls comprise mud bricks which have been plastered. It has had a heavy concrete dado inserted which has possibly added to the degradation of the building. Attempts have been made over the years to repair the building, but with cement plaster.

***Due to its condition and location within the extended development, demolition is an option***

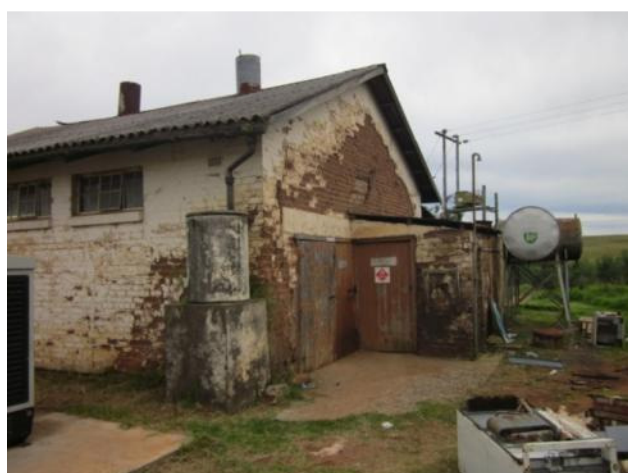
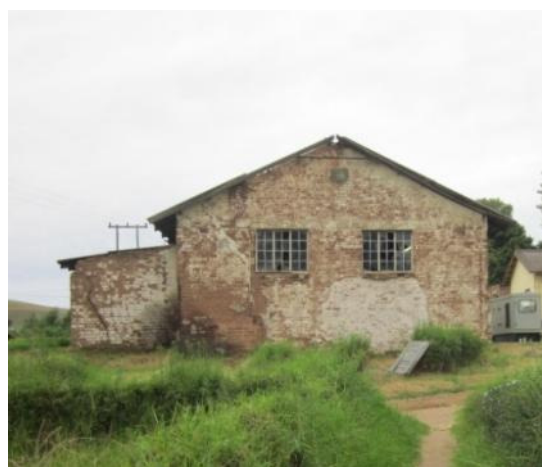
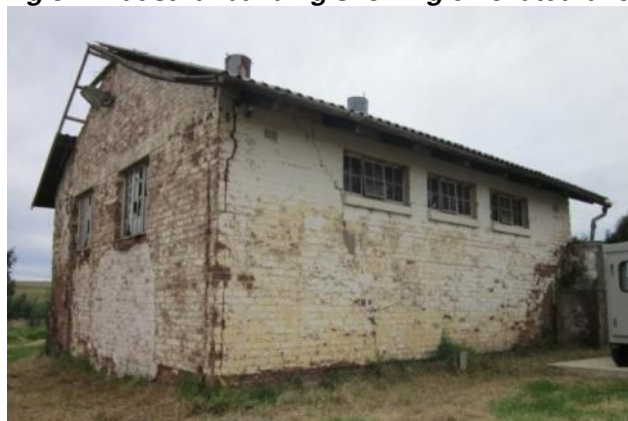
**Fig 31: Industrial building showing exfoliated brick skin Fig 32: Industrial building from north**

**Fig 33: Industrial building from west**

This structure is an old industrial building, possibly functioning as a mill or similar. It is of locally-made brick, with a double pitched corrugated-iron roof and steel windows. Its condition is extremely dilapidated: on the southern side the brick has collapsed to such a degree that the external skin has fallen away, compromising structural integrity.

***Statement of significance: Although this building is most likely over the age of 60 years, it has limited heritage significance and is in a dilapidated condition.***

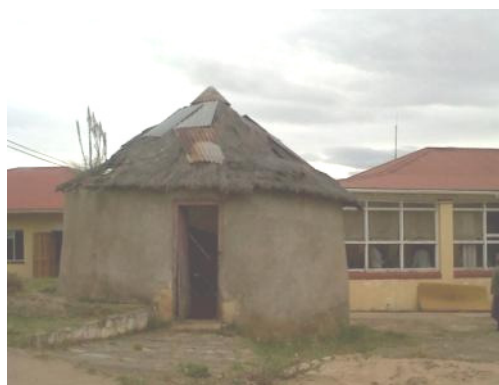
See comments for similar building in 3.5 above. Despite it being in better repair than its counterpart, the practicality of its repair and reuse is limited, and it is felt that it is important to concentrate the repair and reuse of such buildings to other parts of this site.

***Fig 36: Old rondawel against hospital***

**Due to its condition and location within the extended development, demolition is an option**

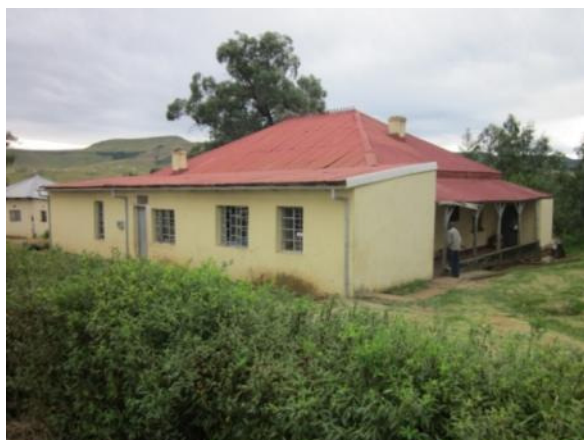
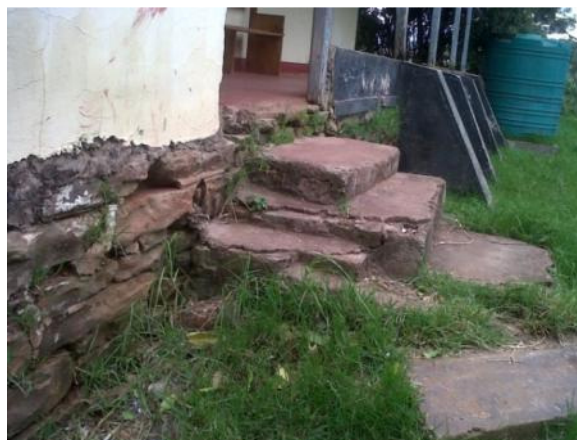
The building is of uncertain construction, most likely a mixture of mud and fired brick, under corrugated sheeting. Windows vary from original sash to standard steel sections, added at a later stage. It is founded on a mixture of shale and sandstone, much of which is exfoliating. Verandas have a simple 'Y' post, and the veranda to the north east is heavily buttressed to prevent it overturning.

**Fig 43: Old Mission building from south east**

**Fig 44: veranda and foundations**

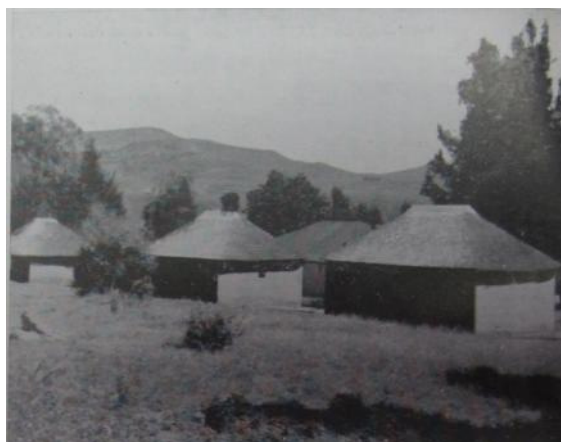
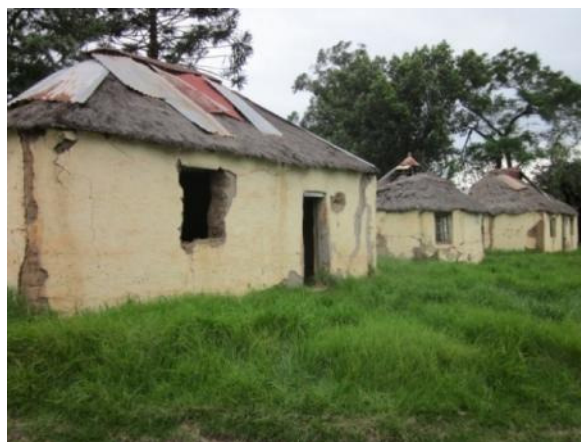
A series of square mud brick cottages is found across the site. Below the main hospital on the eastern slope is a continuous group of four with one located further up the slope, and two which form part of the main complex on the crest of the hill. One of these has been addressed in C6 and the other is situated close to the old mission house, and backing onto hospital buildings of more recent construction. Most, except for the latter, are either totally derelict, or in a sorry state of repair.

**Fig 50: Nurses accommodation ca 1940 (Sulenkama pamphlet) Fig 51: Row of cottages**

*Some of these buildings, especially those on the crest of the hill, fall within the footprint of the new development. Those on the eastern slope are theoretically largely 'untouched' but it is unlikely that they will survive the development. As threatened buildings they should be fully documented, and measured up, and the information form part of a display in the museum. It is highly recommended that one of these buildings should be identified for rehabilitation as an example in the new development. The building situated behind the mission house is possibly the best option. Should renovation or demolition be sought, a full and separate Heritage Impact Assessment should be carried out. All renovation works should be supervised by an appropriately qualified heritage architect. Further research needs to be carried out on the role of the Church of Scotland in the establishment of Sulenkama Mission*

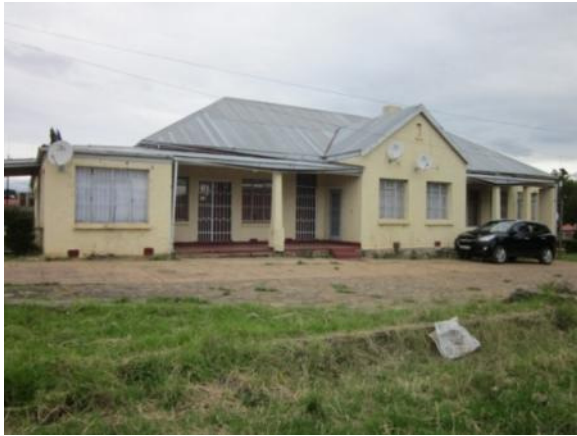
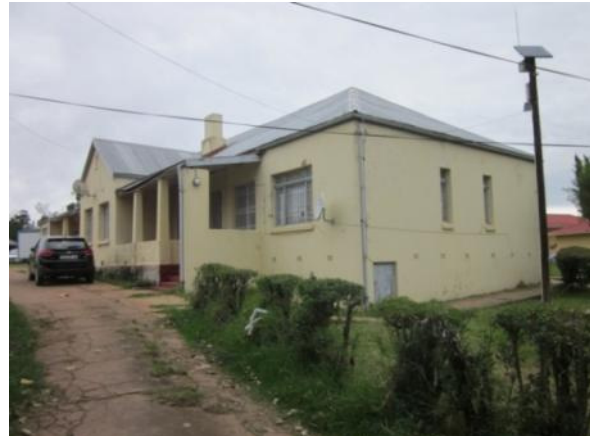
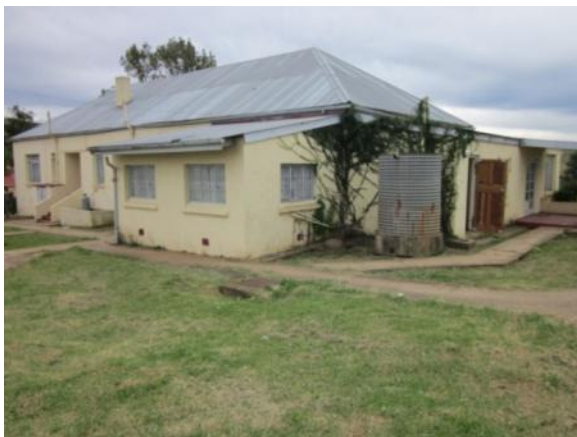
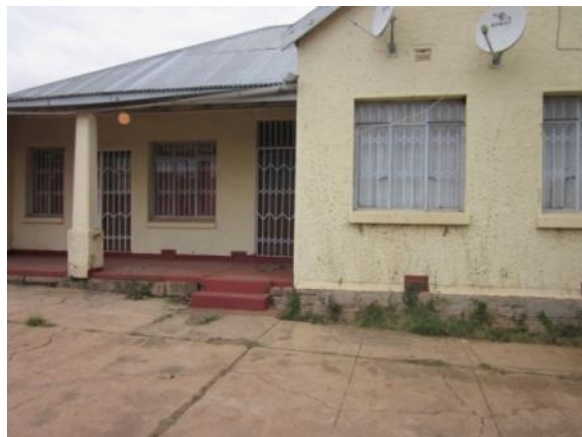
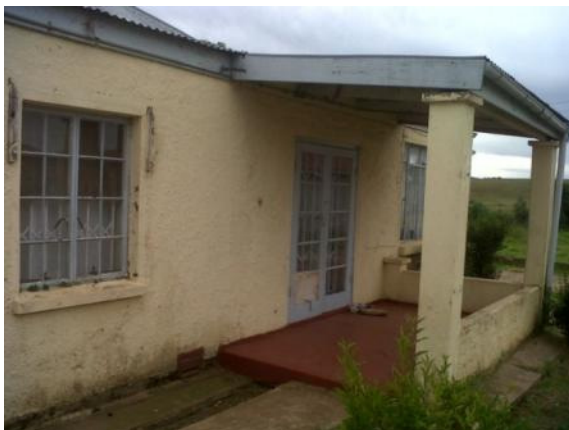
This building is a substantial but simple late Edwardian style house, possibly constructed as the second mission house on the property. It is of locally made brick and mortar, rough-cast plastered and painted. The building is founded on stone, and evidence of this is seen in the rough dressed and pointed stone at dado level. Windows are all of steel, and there is little evidence of these replacing earlier timber ones. Cills are brick on edge, and the variant sub-floor ventilators tell of different stages in its development. Veranda columns are cumbersome tapered columns on a square base. The roof is hipped, with a central projecting bay to the main elevation containing a matching pair of windows.

*It is noted that a portion of this building will fall within the footprint of the new development. It is recommended that the proposal be slightly altered in order to accommodate this house, and prevent its demolition. As a threatened building it should also be fully documented, and measured up, and the information form part of a display in the museum. Should renovation or demolition be sought, a full and separate Heritage Impact Assessment should be carried out on this structure. All renovation works should be supervised by an appropriately qualified heritage architect. Further research needs to be carried out on the role of the Church of Scotland in the establishment of Sulenkama Mission*

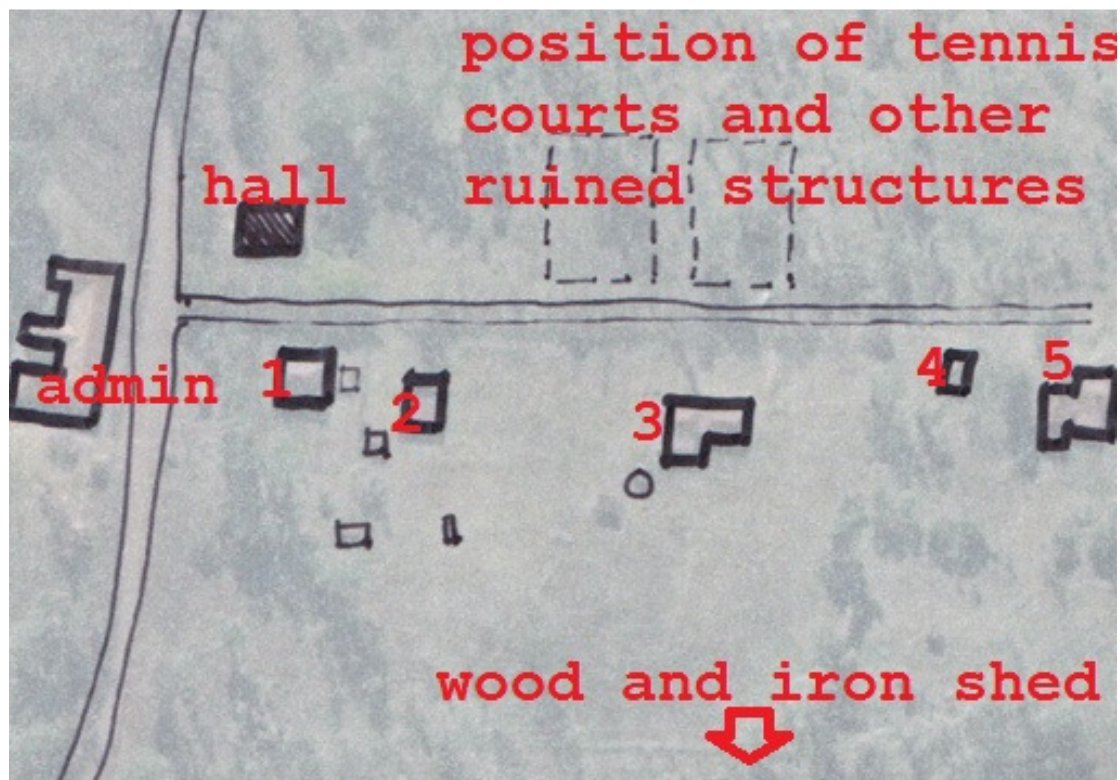
It is highly unlikely that the position of this helipad will benefit the adjacent buildings which are already suffering badly from structural failure, or that these buildings, many of which are in bad repair, are likely to be restored. Thus, they have been briefly discussed, despite that the brief was to deal with the development footprint.

**Fig 65: Layout of site at Mjanyana – Hall is indicated as being demolished but all other buildings (1 through 5) on the other side of the access road are severely threatened.**

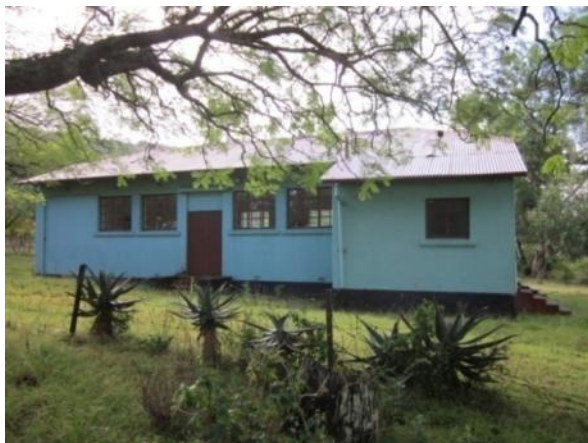
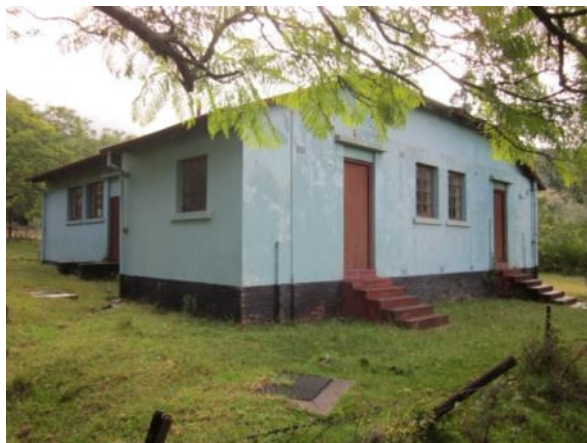
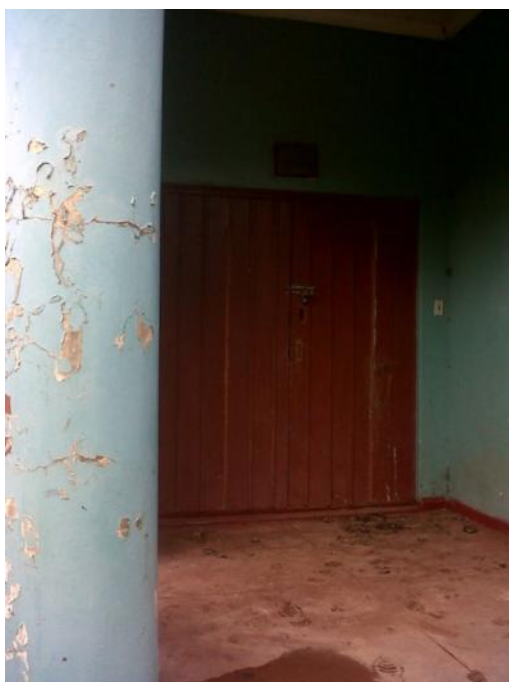
The Thornton Hall building is an unremarkable, clumsy structure with myriad architectural reference points which was opened on 6 December 1958. Thornton was a doctor at Mjanyana from 1925. Its asymmetrical entrance on the north has a peculiarly placed column which is offset from its base and top. Above the double leaved timber painted entrance doors is a plaque noting the date of its opening.

***This building, as noted, has little architectural merit, and its position in the historic community is noted. Furthermore, it is less than 60 years of age, meaning that motivation for its retention in terms of heritage legislation is required. Demolition, should it be required, is an option.***

***However, due to its position in a considered historic precinct on the site It is recommended that the building be measured up and fully documented in order that a record of it within its precinct, is kept, possibly as part of a display in the new hospital. Furthermore, there is much room for much further research into the Mjanayana Leper Institution which can add value to the above suggestion.***

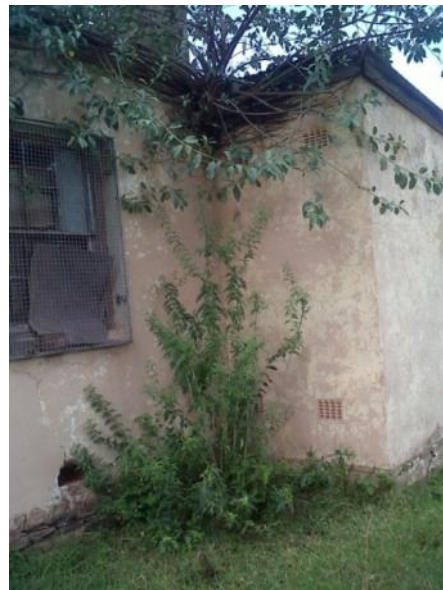
***Fig 73: Wild fig in wall***

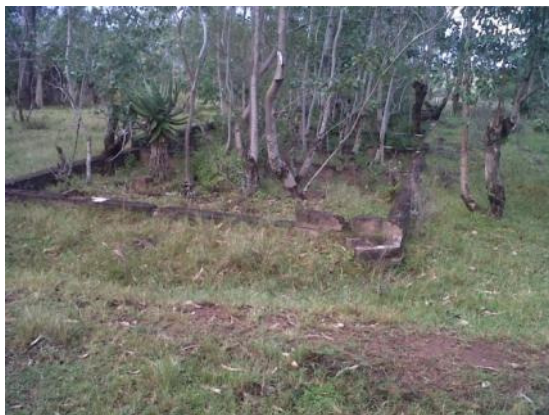
***Fig 87: Ruined foundations to north of access road***

- As in the recommendations regarding Thornton Hall – the building should be measured up and photographically documented in its context.
- That all the buildings and features including the canalisation on the south side of the site, as well as the admin block, be similarly documented, in order that a total site plan of the precinct can be compiled for the architectural and historical record.
